Cam roller Assembly Replacement

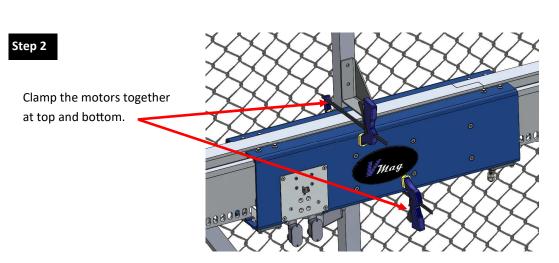
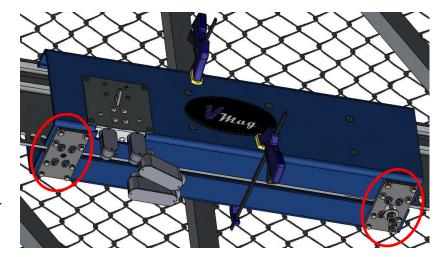
Removing the linkage arm is optional.

Remove all 16 of the 1/4" hex bolts holding the motor brackets on.

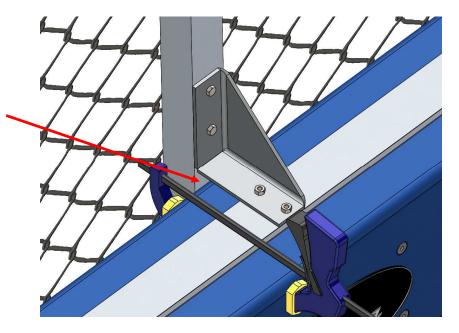
Step 4

Using cardboard or a piece of wood, wedge the back of the motor to the vertical gate member

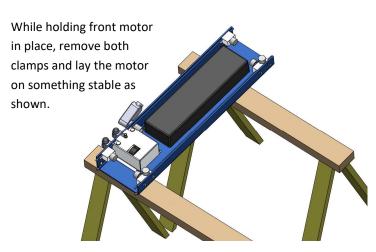
Step 5

Remove the 12 point bolts, to remove the cam assembly.

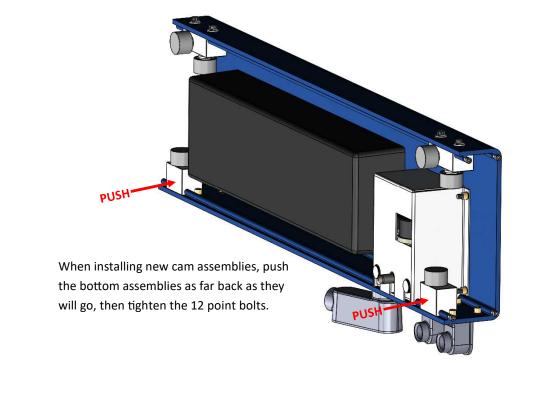
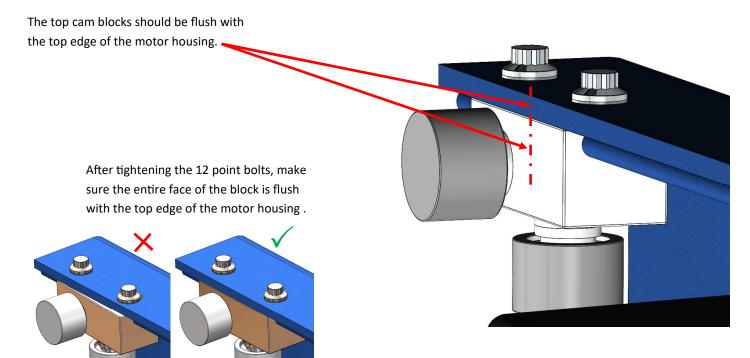
Re-install both motor assemblies.

The bottom cam rollers should be making contact with the reaction fin face and be able to rotate with fingers with some resistance. Re-adjust the proximity sensor gap on both sensors (*see next page for procedure*).
